SAMPLE PROPERTY SURVEY

Apartment 4

Prepared following the guidelines of the Royal Institution
of Chartered Surveyors (RICS).

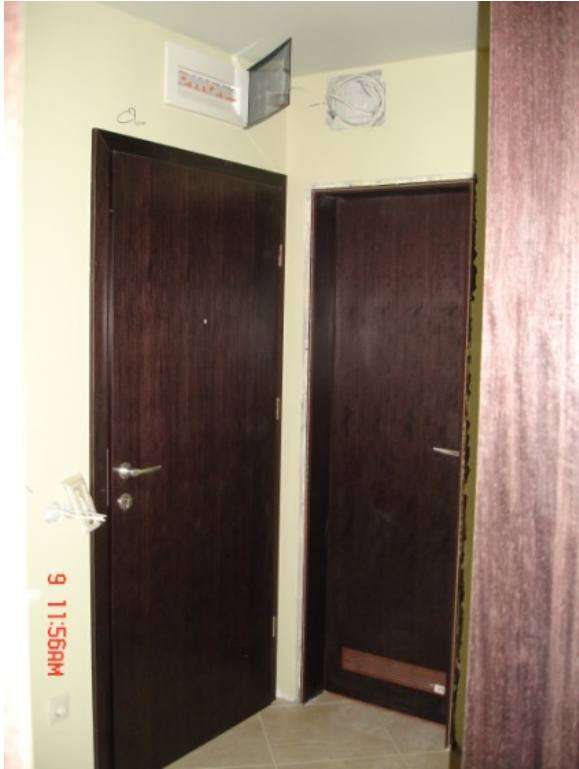
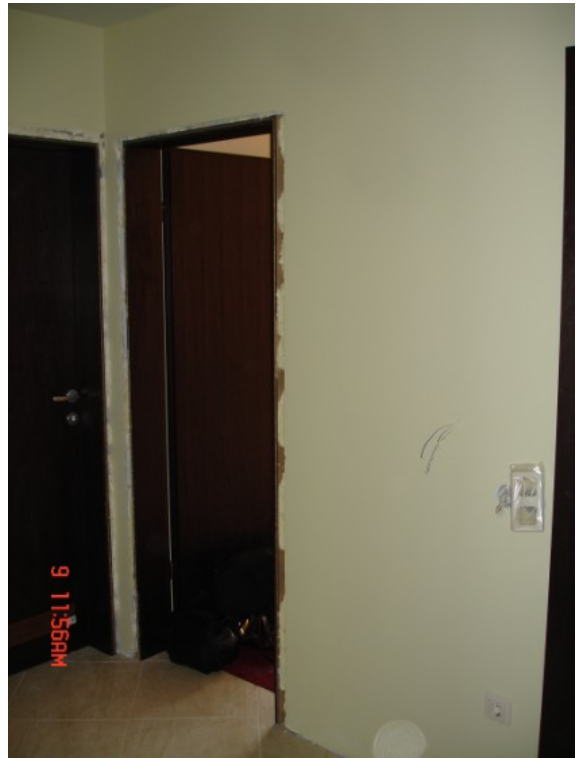
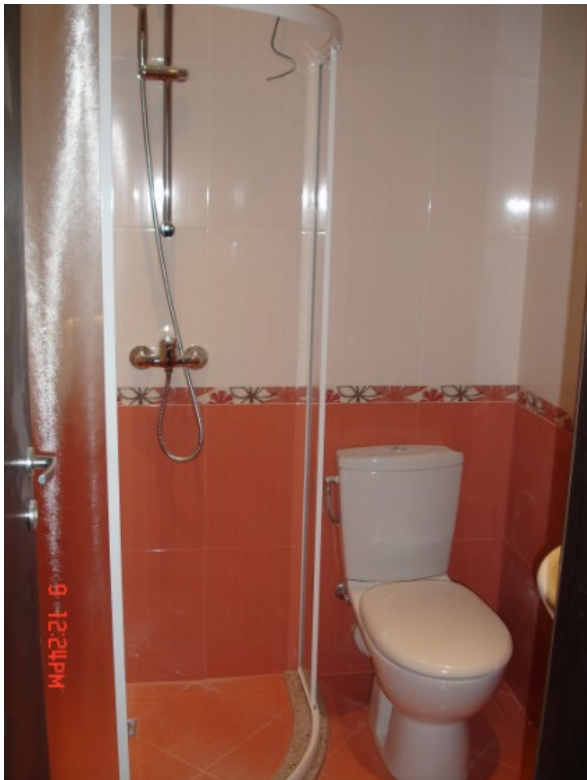
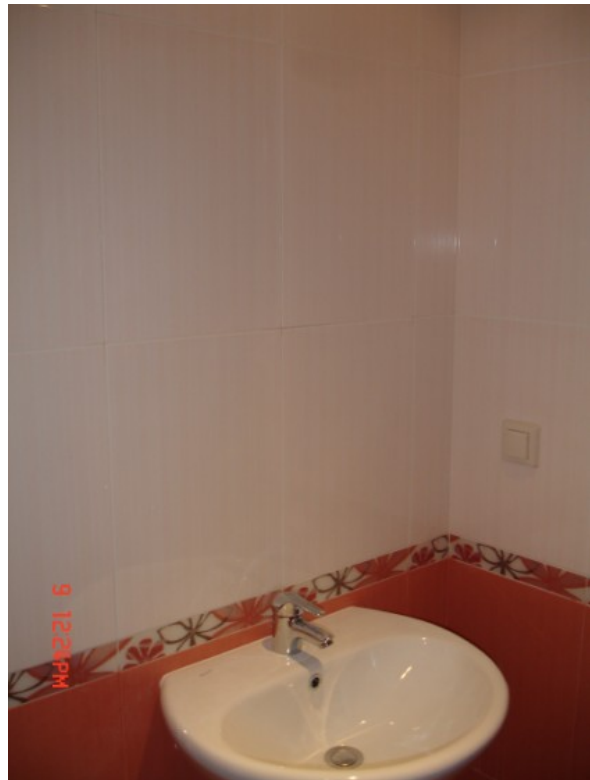
The apartment is on the second floor and its main door is straight in front of the stairs. Go through the entrance door into the HALLWAY (4.1 on the plan). Mounted main electrical panel, single socket. **Intercom not installed, switches not installed, no cover on cable T.V box. Skirting of the terracotta tiled floor is not placed. The outer frames of the doors were not installed.**

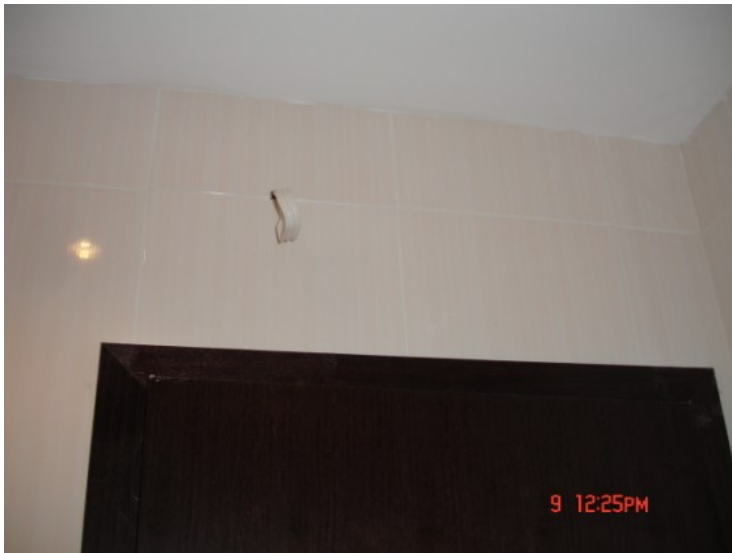
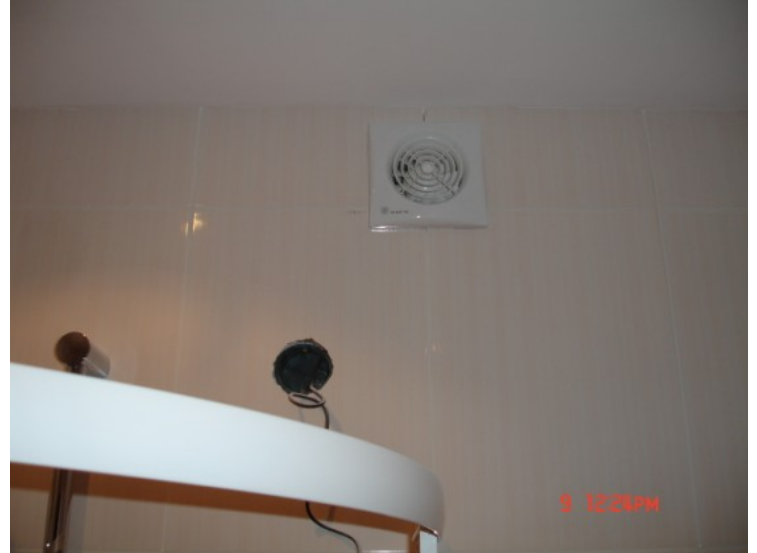
Bathroom equipped with a shower unit, toilet, sink, fan and a single waterproof socket. Floor and walls- tiled with ceramic tiles and properly placed. Ceiling- painted with lime-cement plaster with latex laid on top. Extractor fan properly installed above the shower unit. Heater above the door - not installed though the wiring was provided. No mirror and accessories installed.

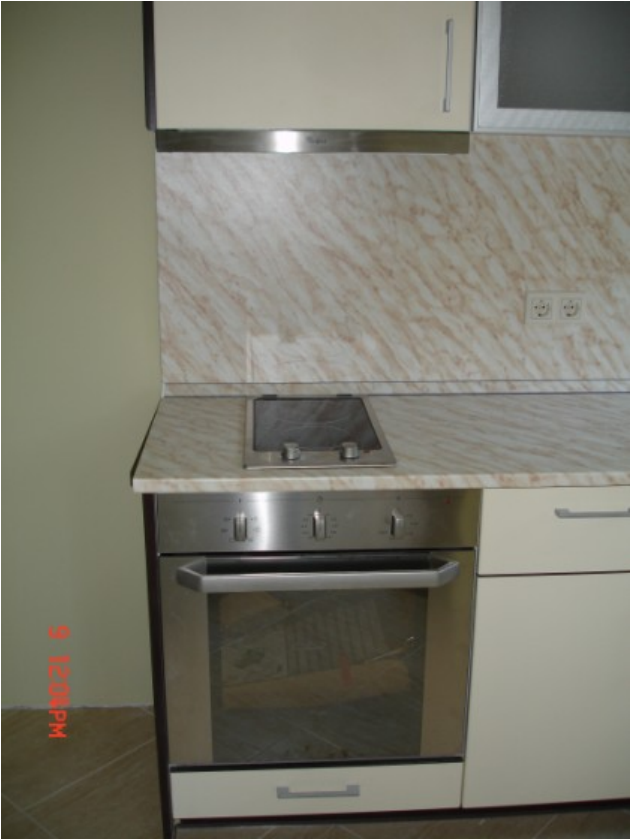
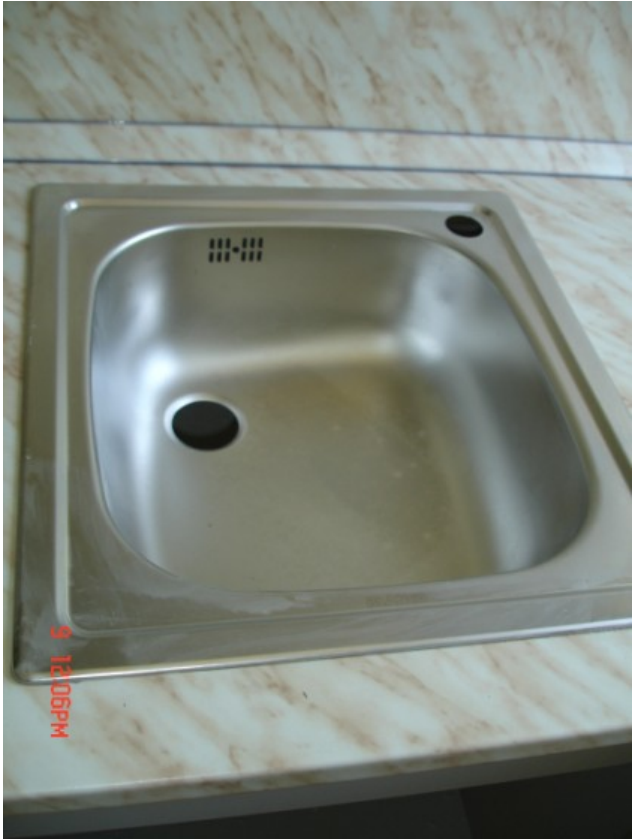
kitchen sink. One double socket above kitchen top. **Battery and faucet - not installed.**

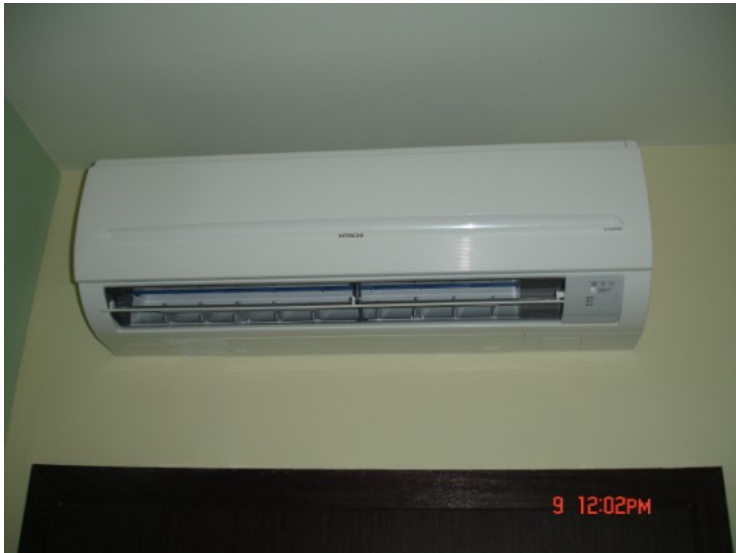
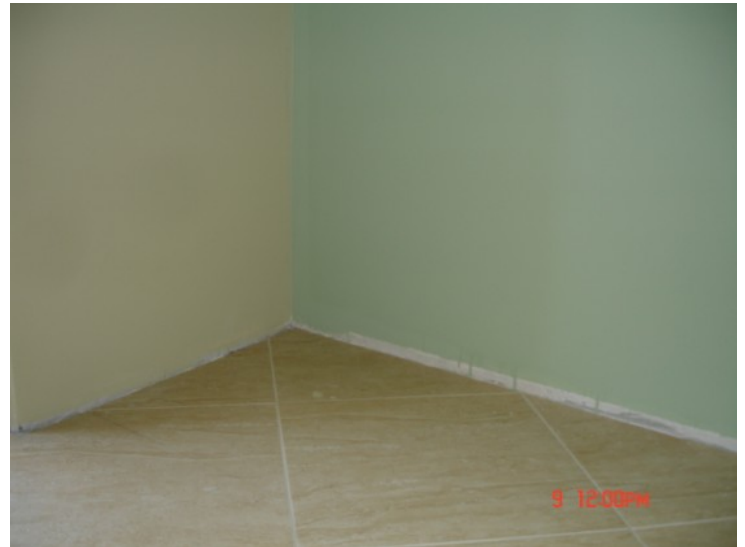
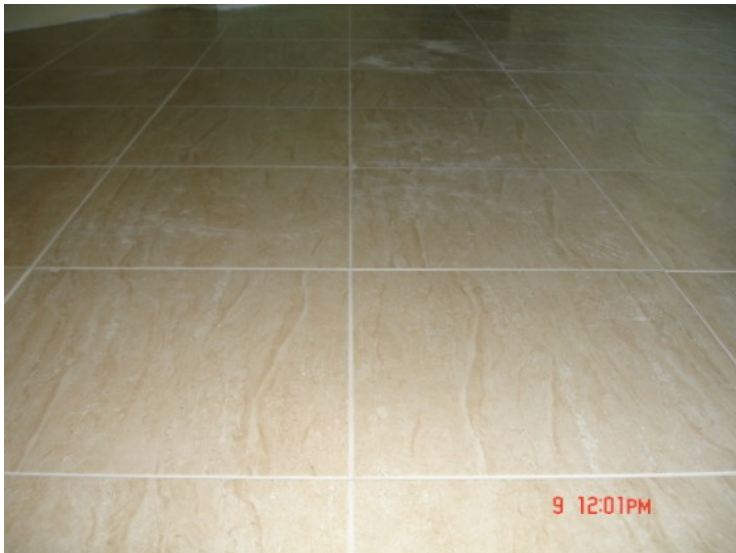
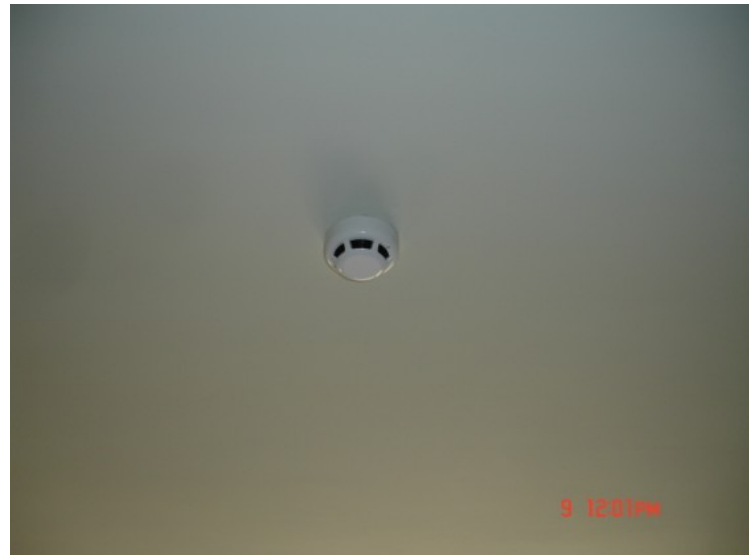
Inverter air-conditioning unit mounted above door. Fire-alarm sensor mounted on ceiling. **Missing lights switches on walls. The skirting along the walls is not placed. Lights not placed.**

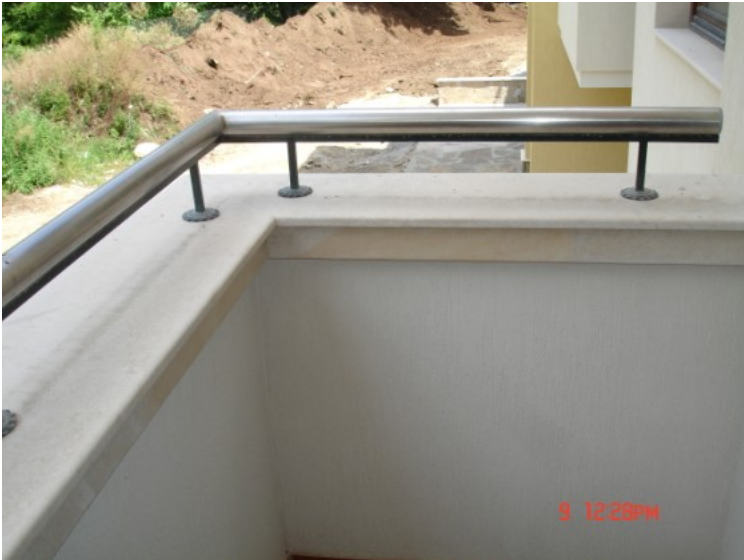
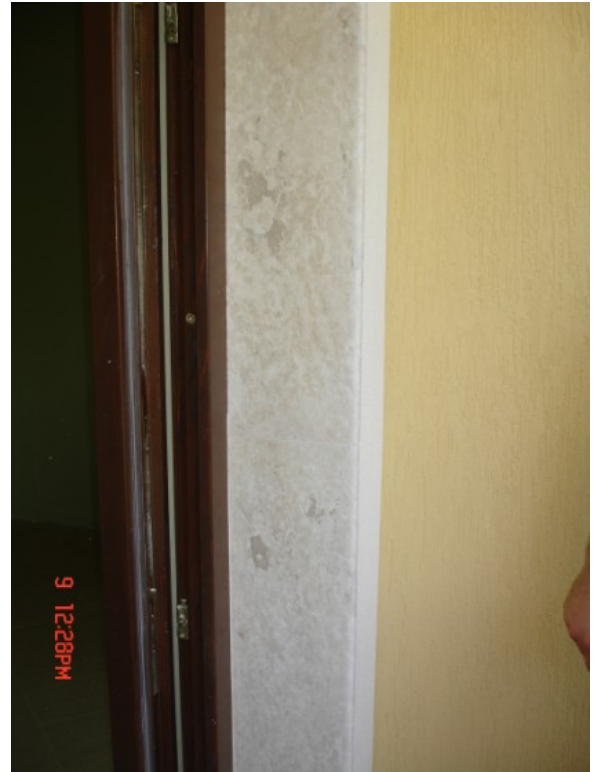
Floor- fine stoneware tiles evenly placed. Walls- completed façade plasters. Railing of metallic powder laid colour, handles of stainless steel. **No light body installed.**

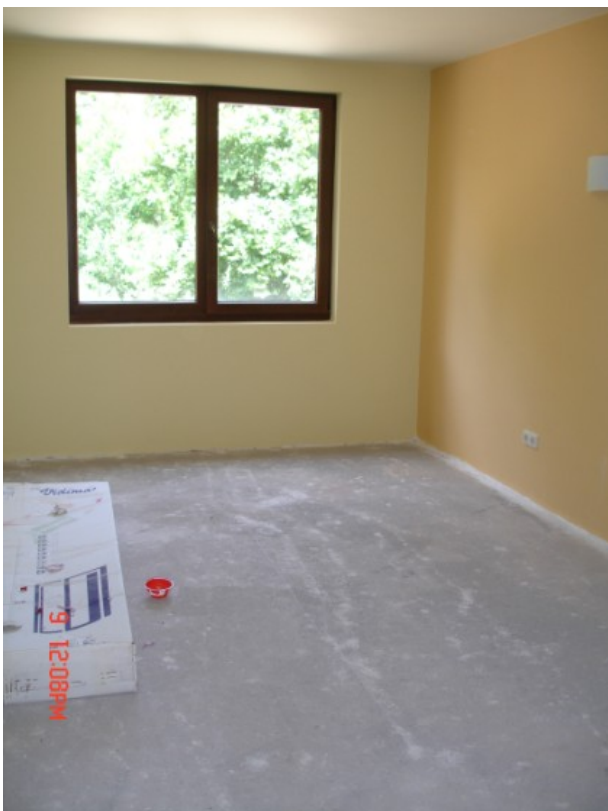
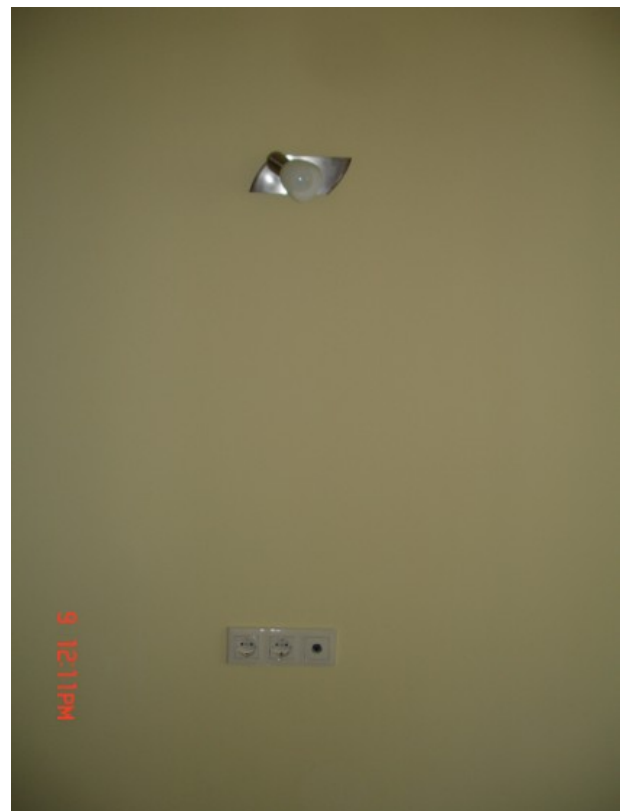
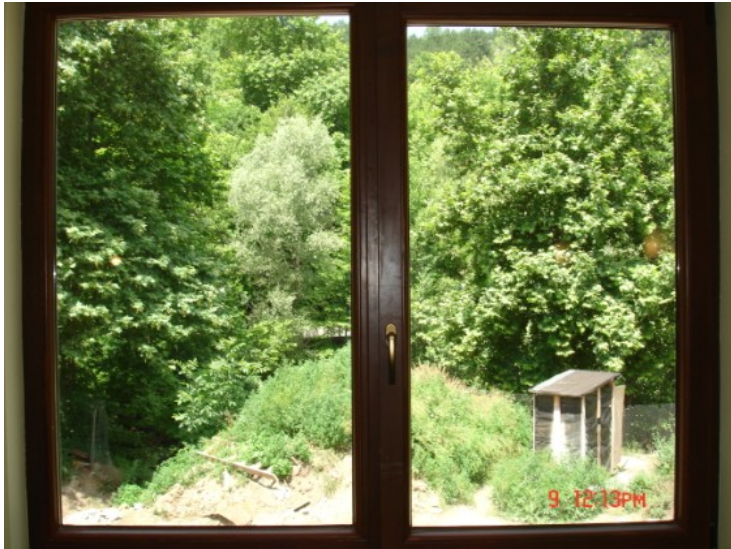
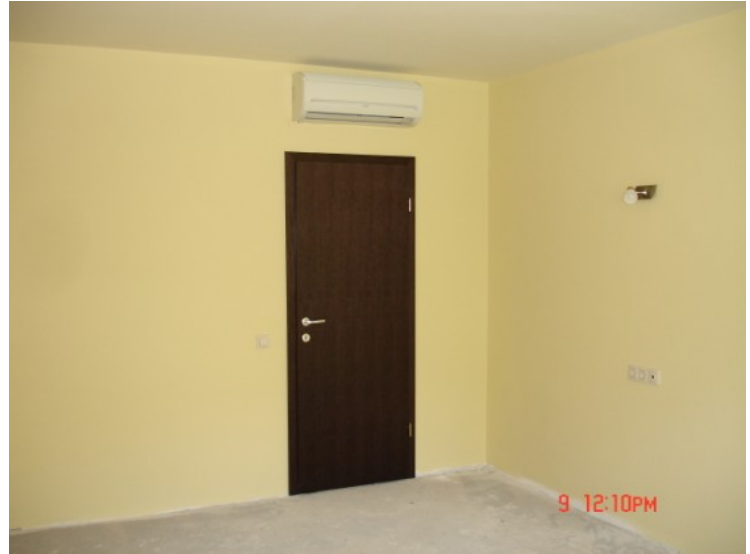
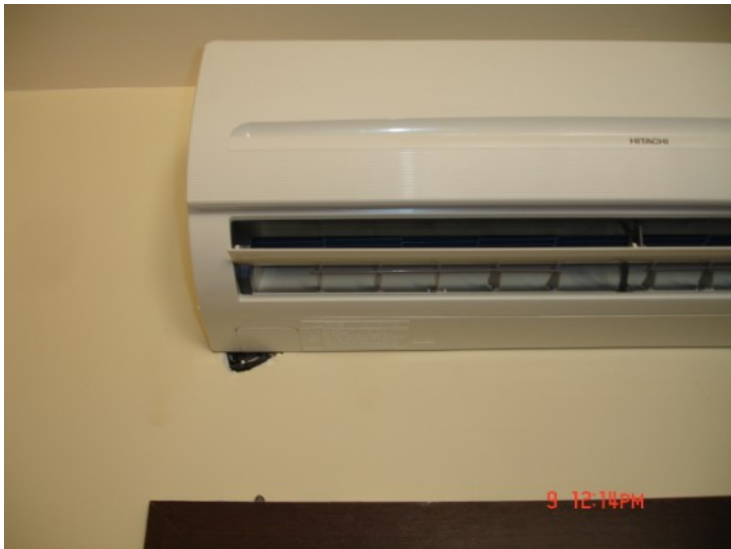
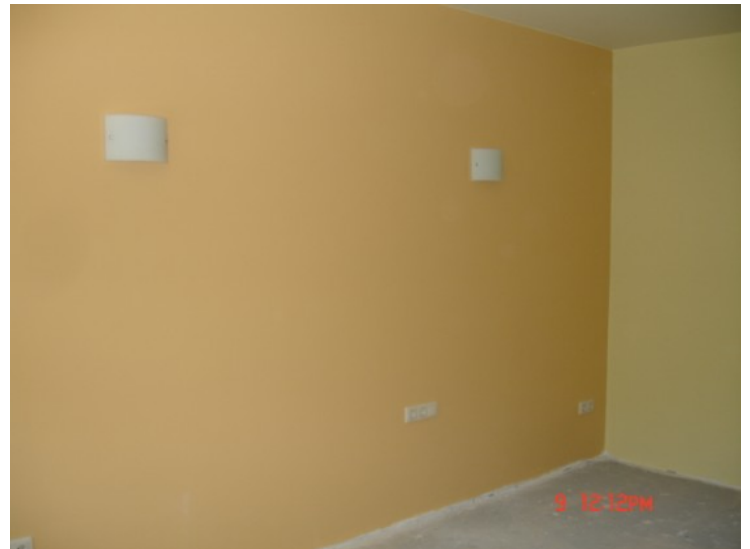
Floors- fitted carpet –**not placed**. Walls and ceiling- puttied and painted, latex laid. One double glazed wooden three-layer window facing West overlooking the nearby forest and river. Invertor air-conditioning unit mounted above door. Fire-alarm sensor mounted on ceiling. One double socket and T.V. point on Southern wall, 2 double sockets on Northern wall. Lights installed on Southern wall. **Light switches not installed. Small hole under air-conditioning needs fixing.**

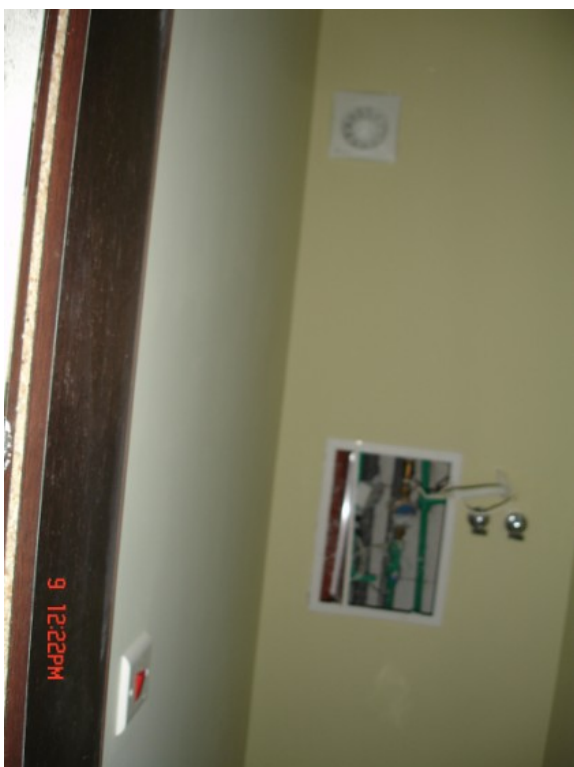
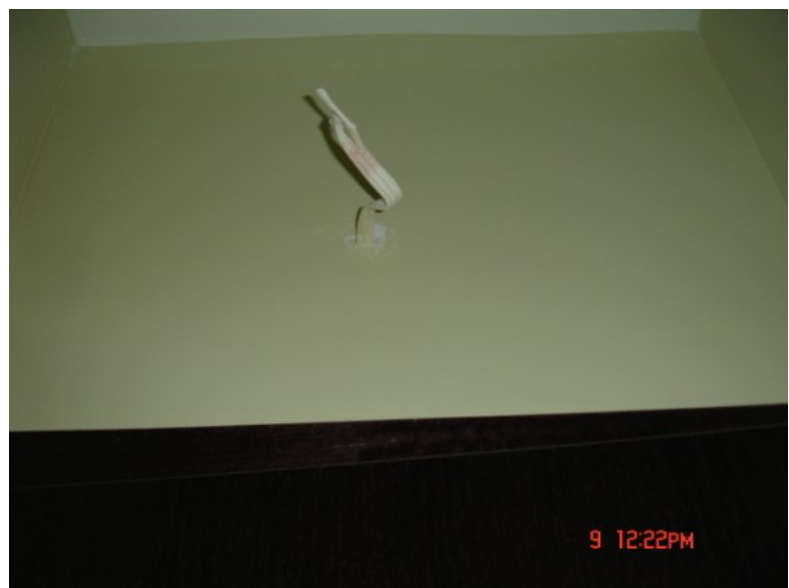
Mounted air extractor. Water metering device installed. Hot water boiler and light body not installed.

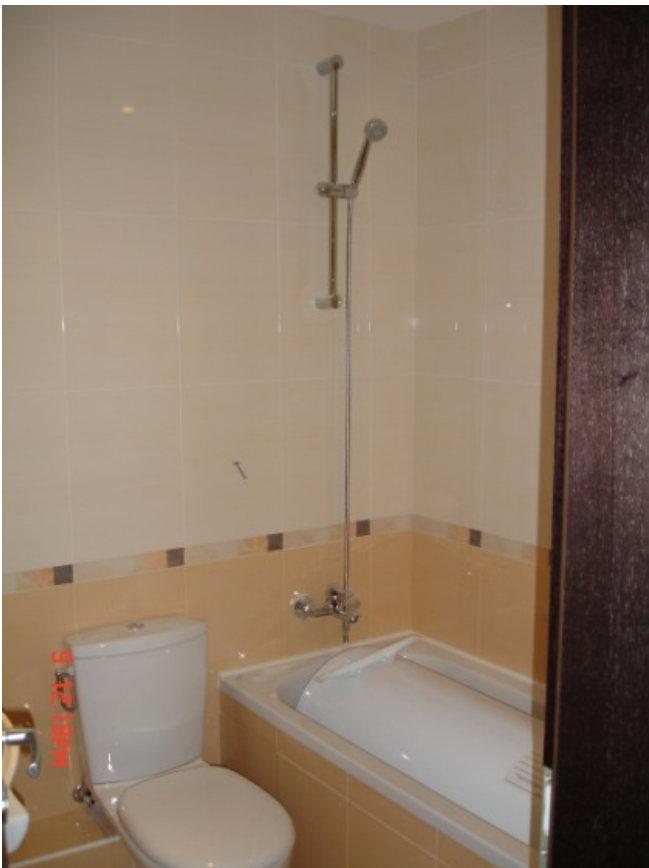
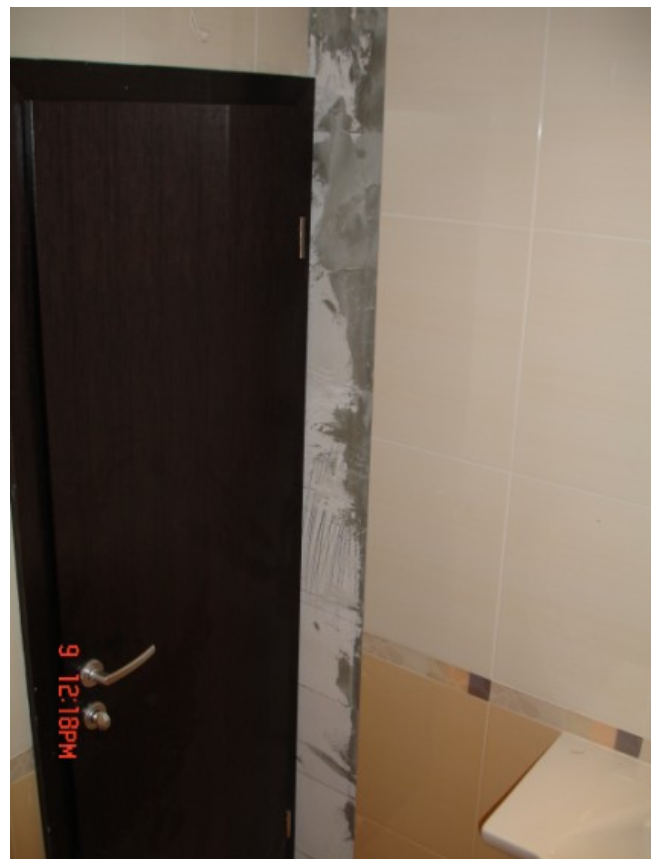
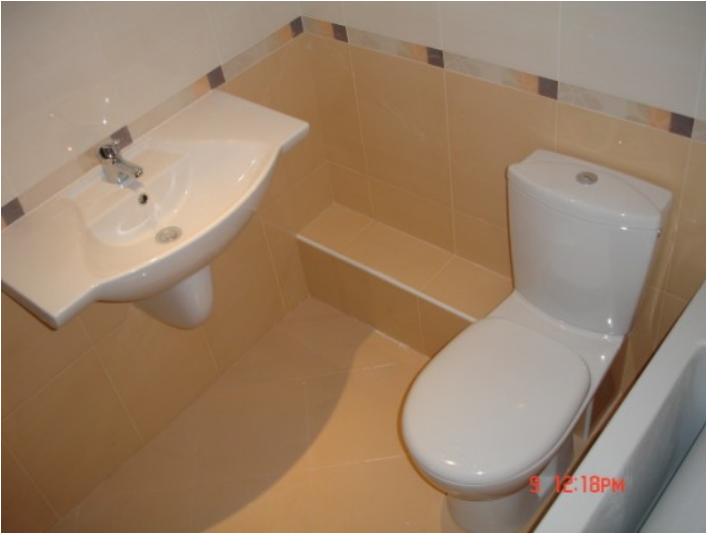
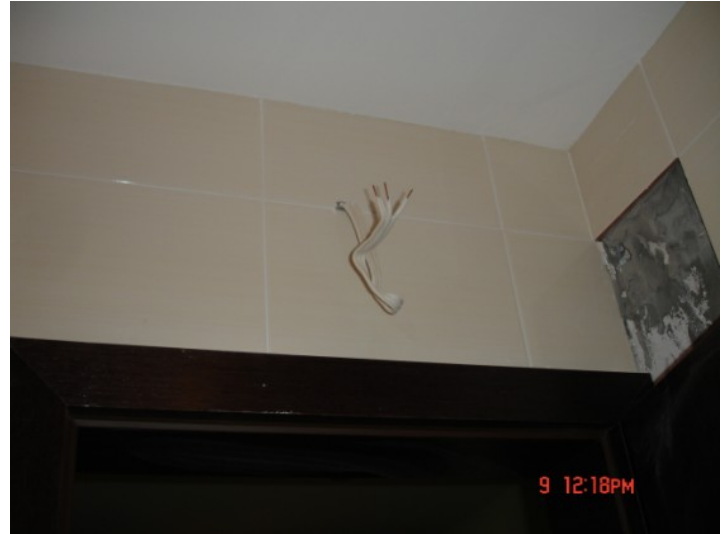
Bathroom is equipped with a bath, toilet, sink, fan and a single waterproof socket. Floor and walls- ceramic tiles- properly placed. Ceiling- painted with lime-cement plaster, latex laid on top. Extractor fan is properly installed above the shower unit. Some tiles behind the door- not placed. Heater above the door not installed though the wiring is provided. No mirror and accessories installed.

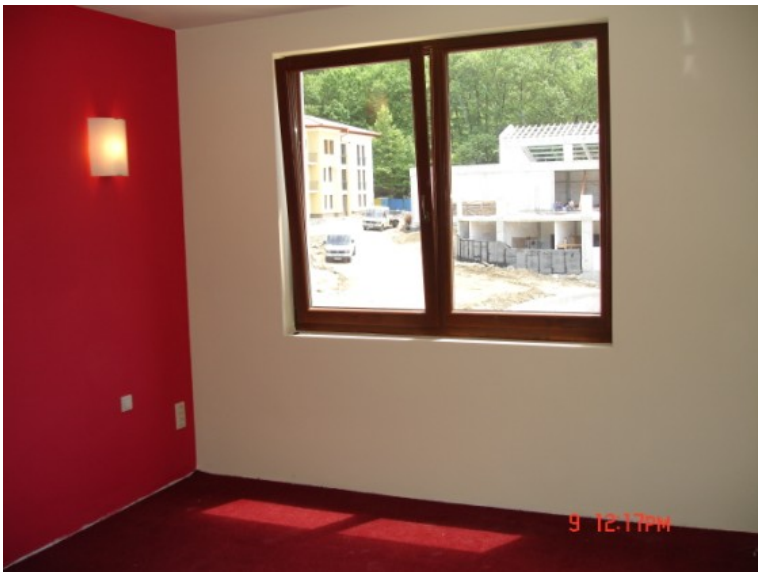
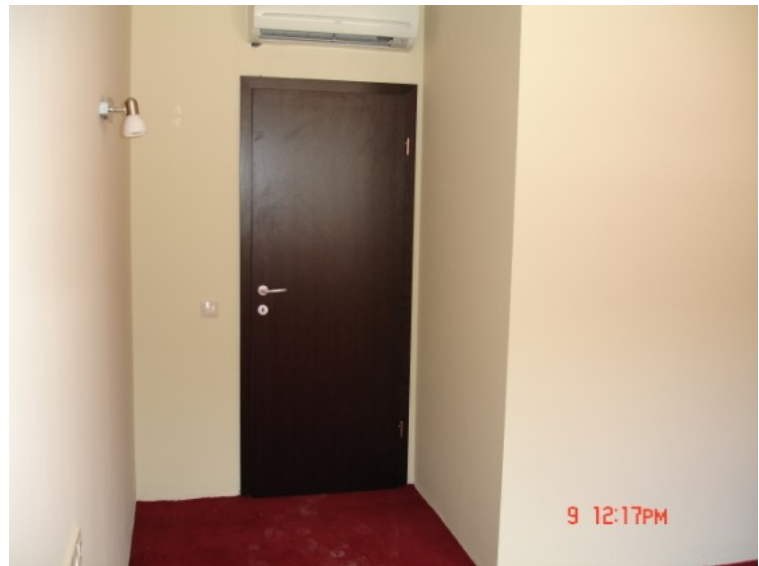
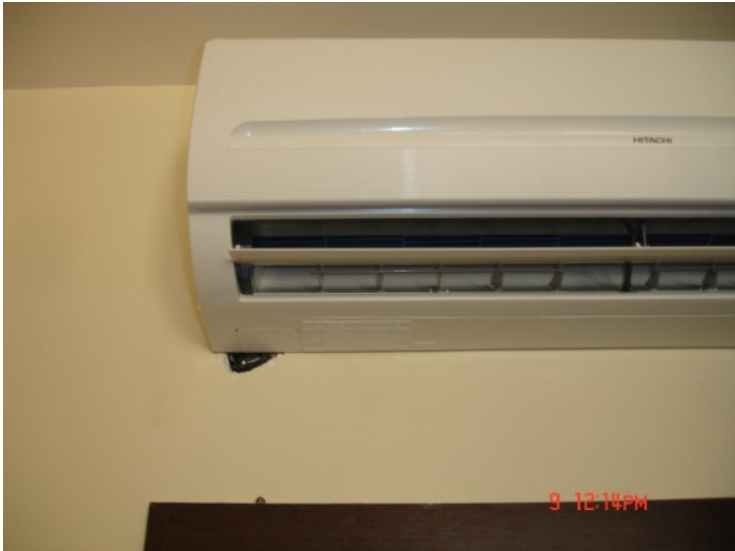
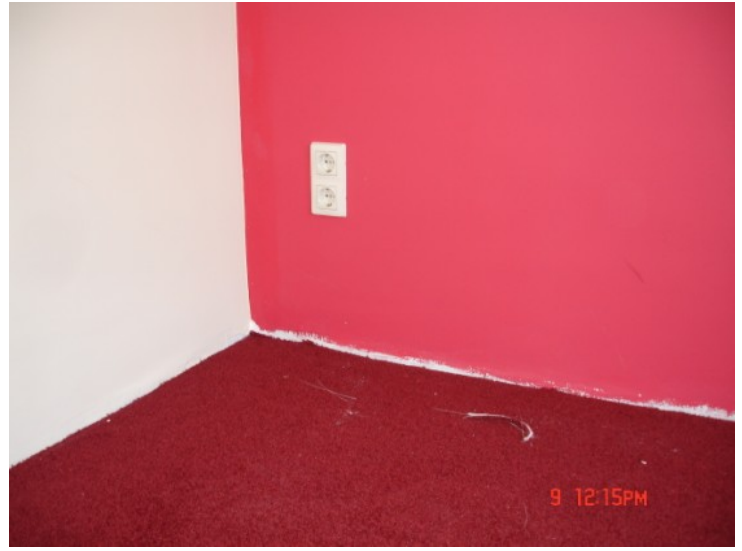
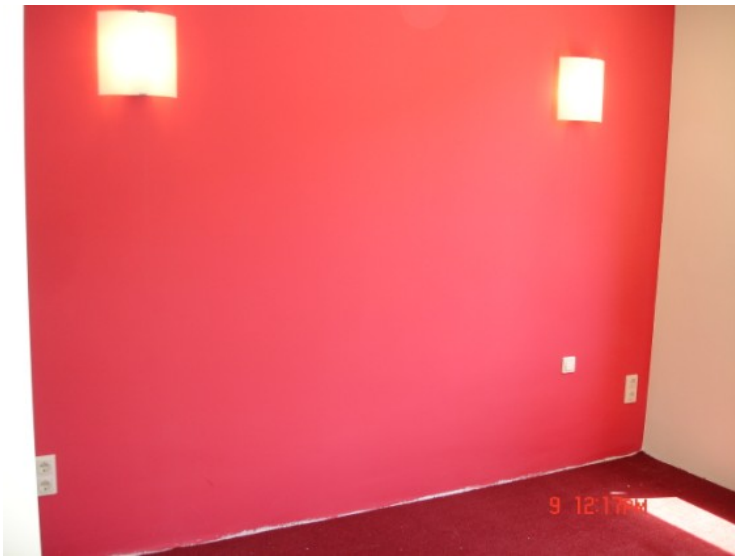
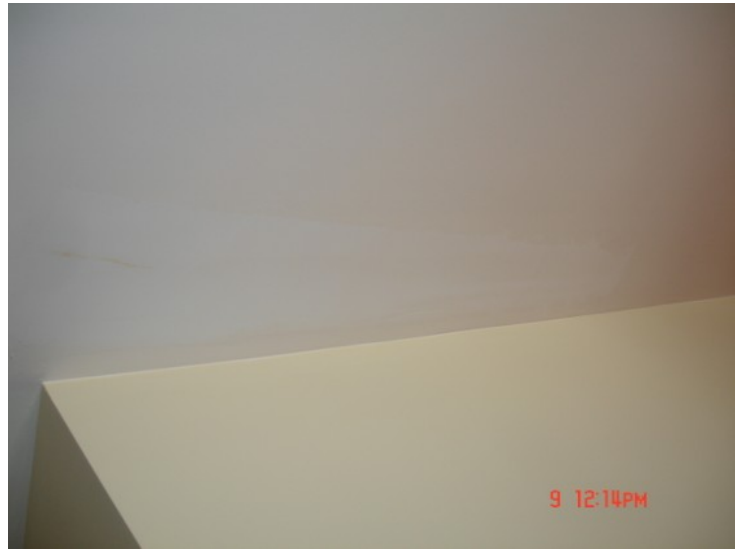
Floors- fitted carpet. Walls and ceiling- puttied and painted, latex laid. One double glazed wooden three-layer window facing East overlooking the front of the building and the swimming pool. Invertor air-conditioning unit mounted above door. Fire-alarm sensor mounted on ceiling. One double socket and T.V. point on Southern wall, 2 double sockets on Northern wall. Lights installed on Southern wall. **Skirting of carpet not placed. Small hole under air-conditioning needs fixing. There is a spot on the ceiling which is not painted well and need repainting.**

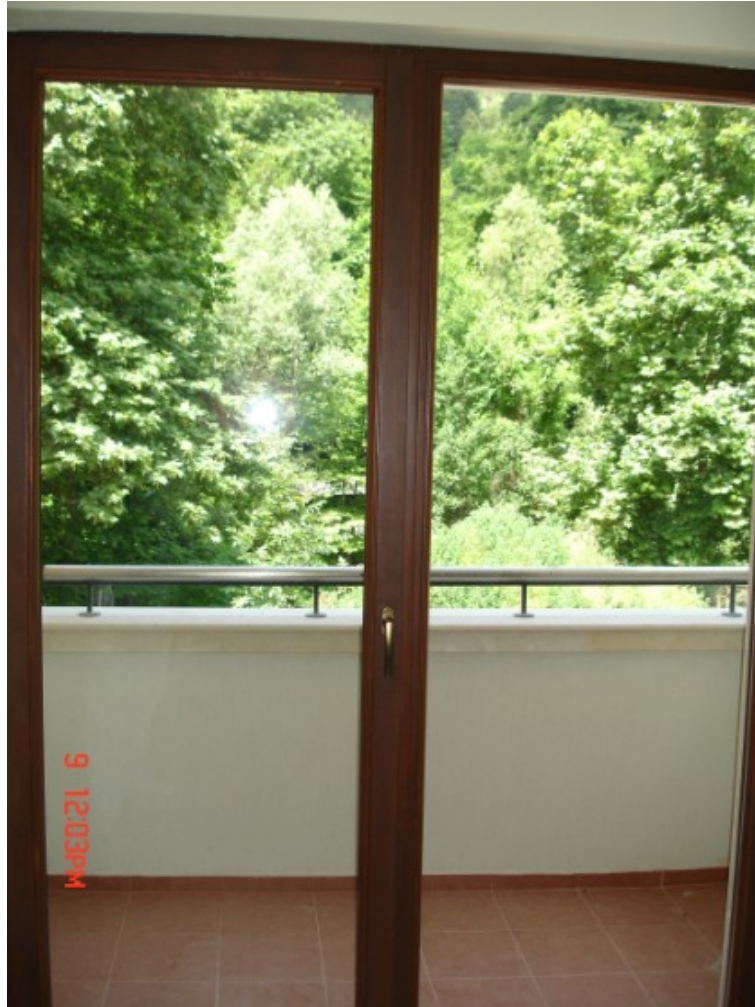
The inner windowsills were not installed at the time of the inspection.

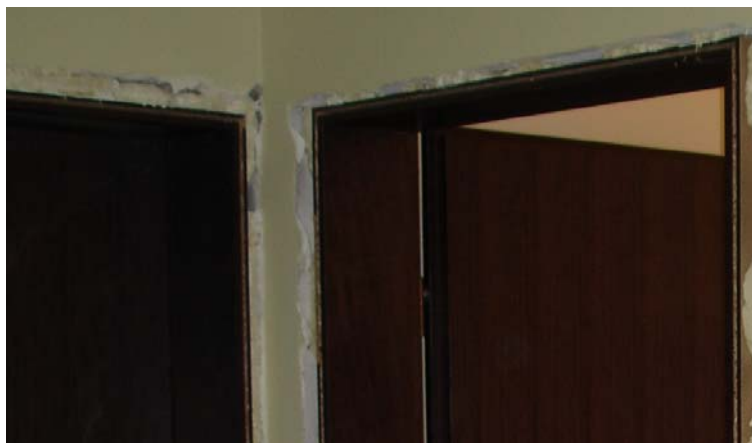
The internal joinery is considered to be of good quality and properly installed. All interior doors are smooth and veneered. **The outer frames of the door were not installed.**

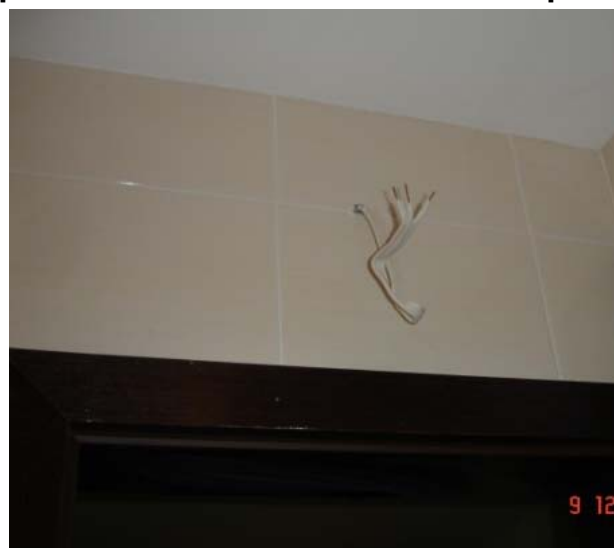
According to the project there should be mounted electrical heaters above the doors in each of the bathrooms. **Those were not installed at the end of the inspection. The power cables of the heaters were in place.**
