SAMPLE PROPERTY SURVEY

Apartment 4

Prepared following the guidelines of the Royal Institution
of Chartered Surveyors (RICS).

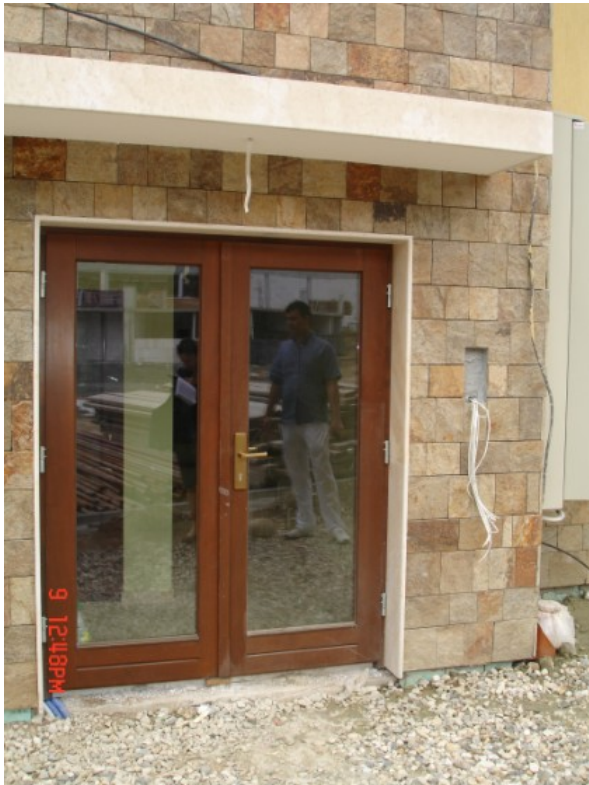
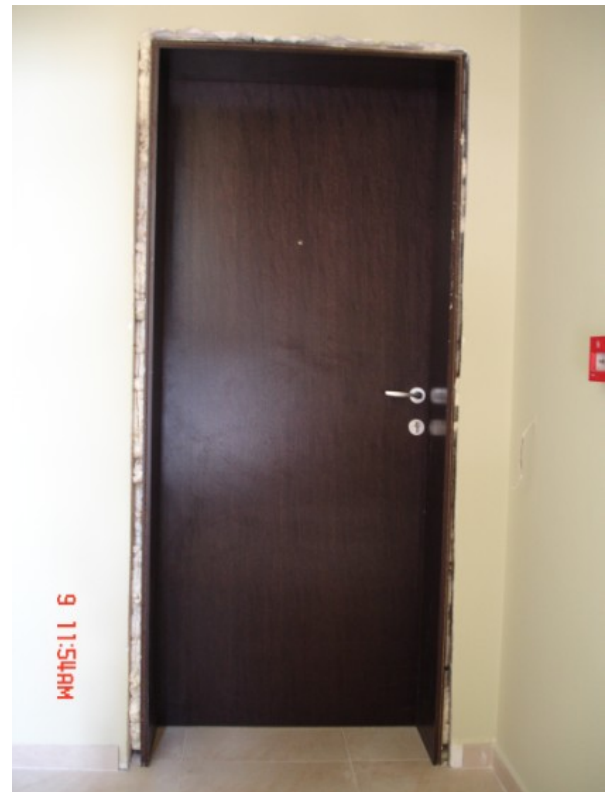
The apartment is on the second floor and its main door is straight in front of the stairs. Go through the entrance door into the HALLWAY (4.1 on the plan). Mounted main electrical panel, single socket. **Intercom not installed, switches not installed, no cover on cable T.V box. Skirting of the terracotta tiled floor is not placed. The outer frames of the doors were not installed.**

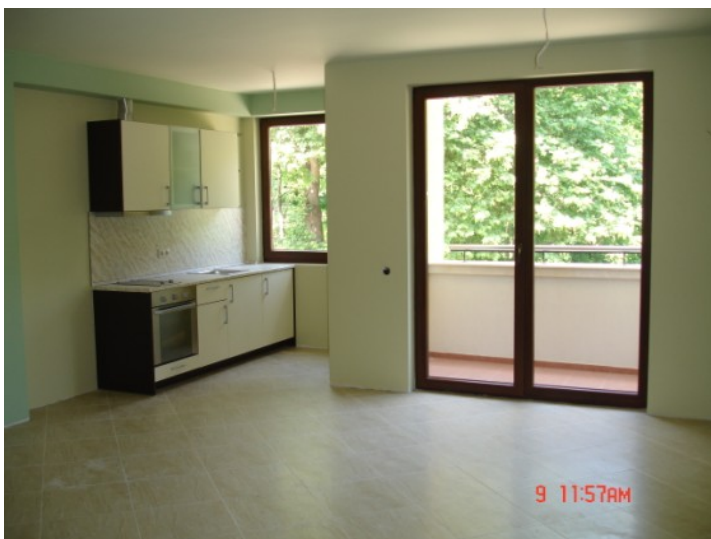
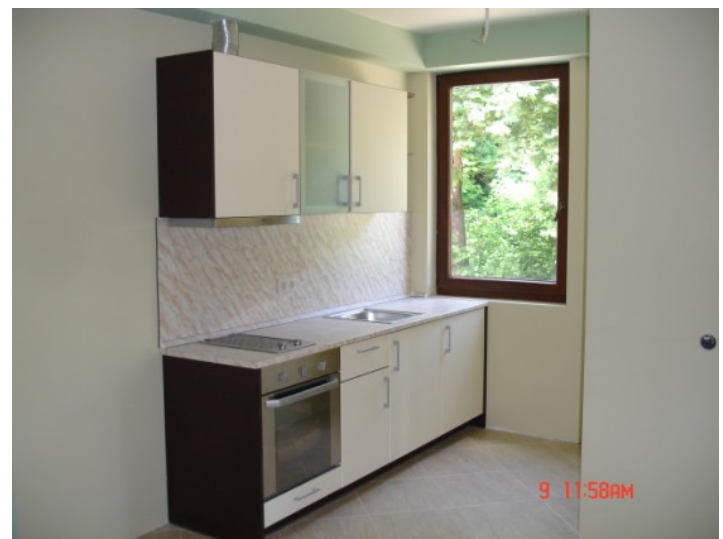
Door to the left leading to THE LIVING/DINING ROOM AND KITCHEN UNIT 4.2

Walls and ceiling puttied and painted, latex laid. One wooden three-layer double glazed window overlooking the nearby forest and river and one double glazed French window with door leading to the terrace. The ceramic flooring (terracotta) - evenly placed. Fitted kitchen with all appliances (oven, ceramic plates, extractor, and fridge) and

kitchen sink. One double socket above kitchen top. **Battery and faucet - not installed.**

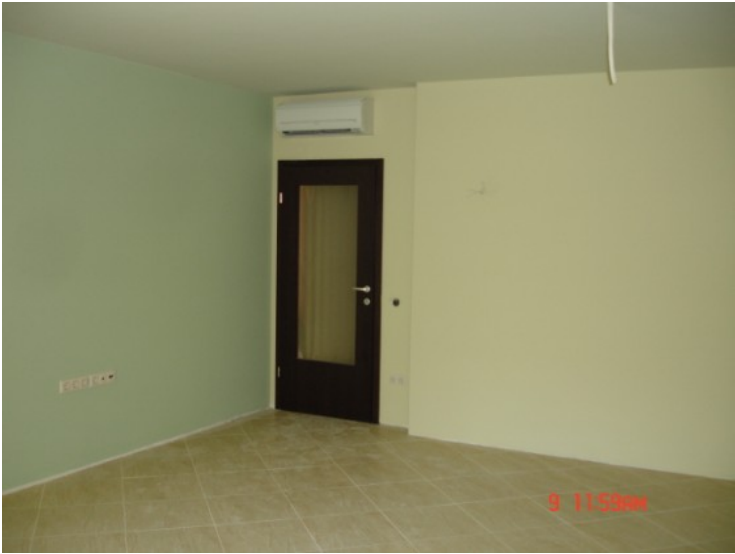
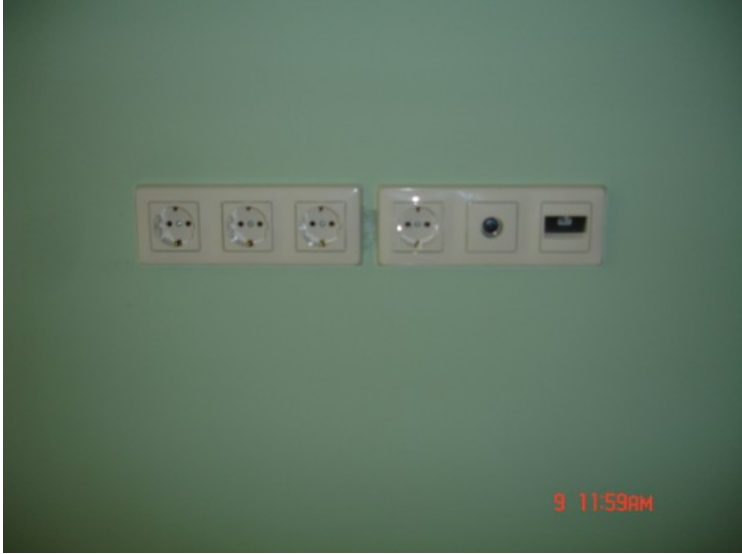
2 double sockets on the Eastern wall , one single socket on wall against the kitchen cupboards, 4 sockets, cable TV point, and internet point on the Northern wall.

Inverter air-conditioning unit mounted above door. Fire-alarm sensor mounted on ceiling. **Missing lights switches on walls. The skirting along the walls is not placed. Lights not placed.**

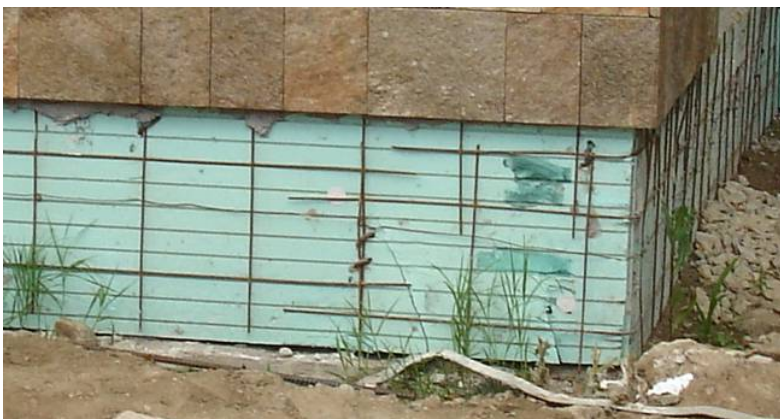
Thermal insulation on walls is impregnated with 5 cm stabilized façade expanded polystyrene, non-flammable, with excellent thermal isolating qualities, good steam permeability (allowing the isolated building to be able to breathe), aging and crumble resistant, stuck and tackled with dowels, with a completing layer – ground coat with armoured net and laid polymer façade plaster upon a net of a colour.

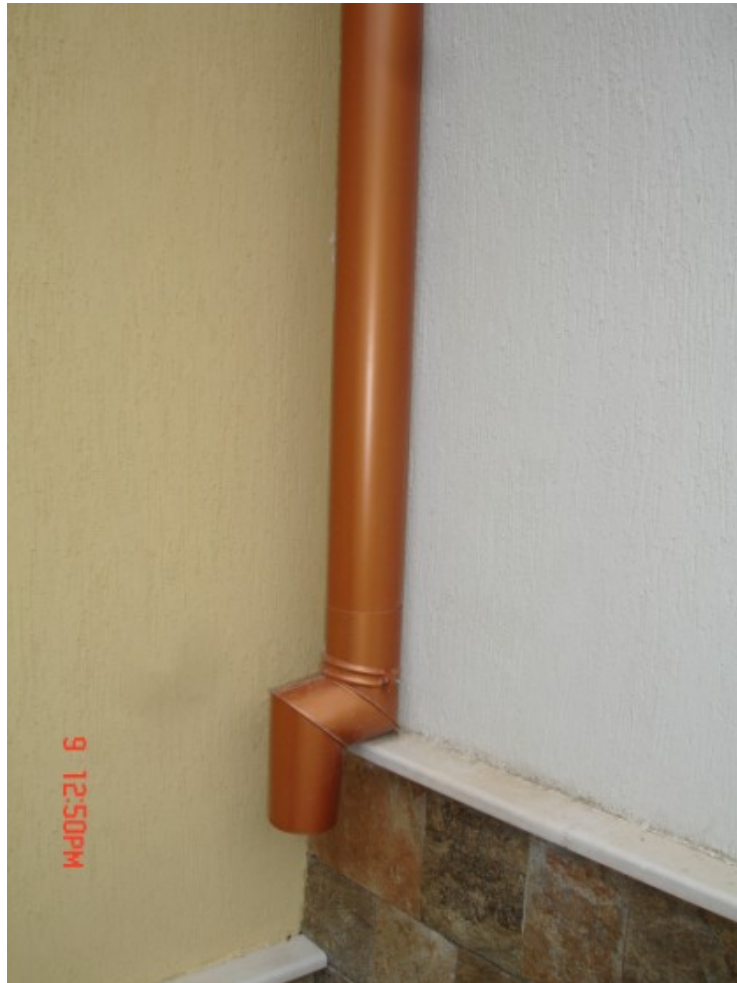
Rainwater fittings are of a conventional, modern copper type throughout and are properly placed and in good condition.

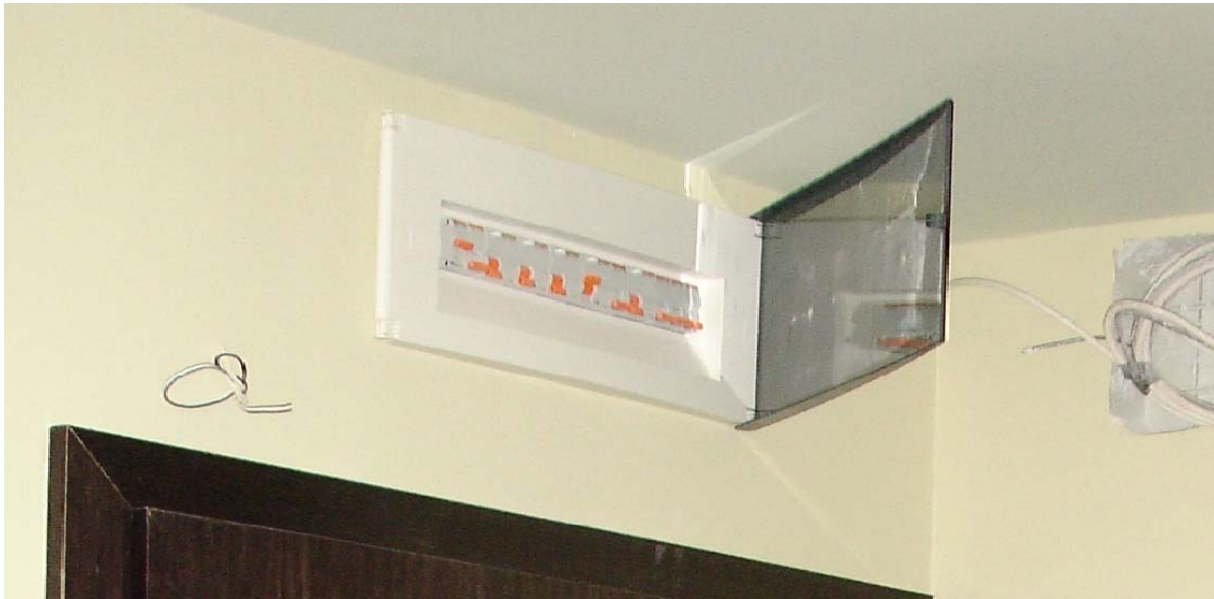
Mains supply is located in the hallway. There is a mounted electrical fuse box panel located at the entrance to the apartment.

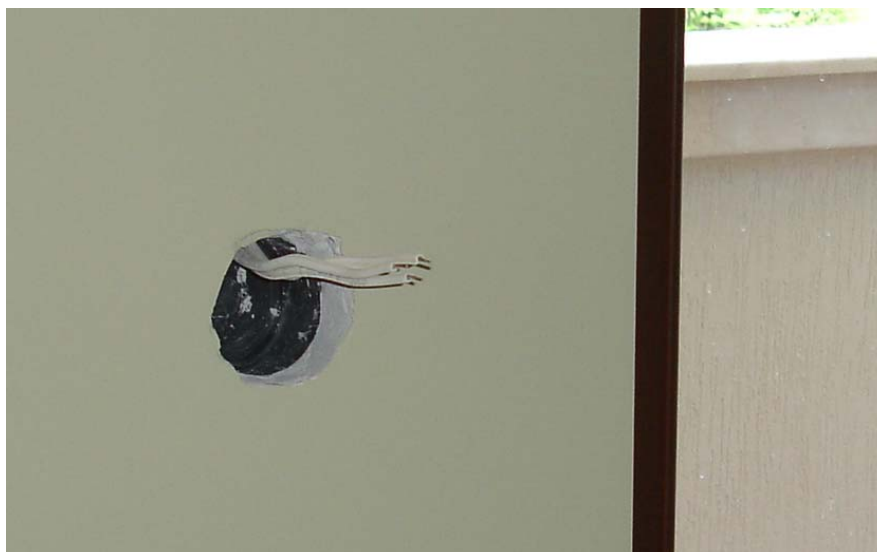
There are mounted conductors on the consoles of the switches, lamp extensions, mounted switches (some were missing) and plugs according to the specifications of the project.

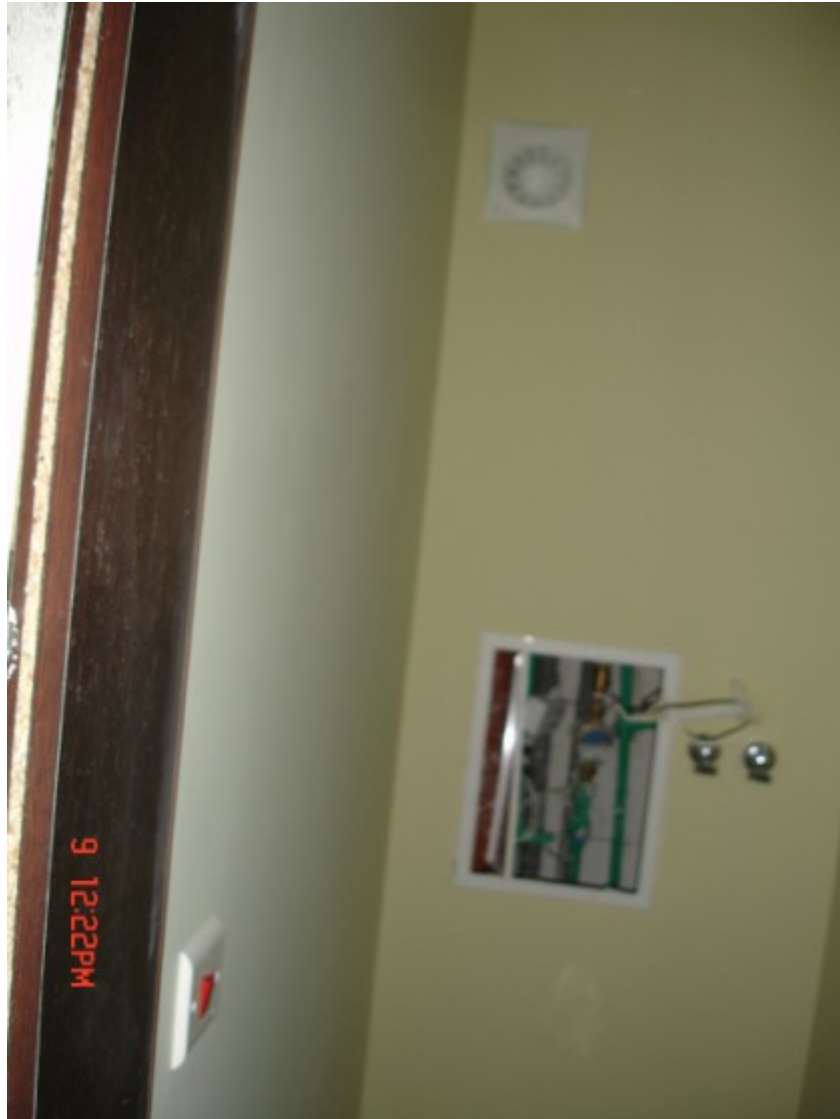
The Mains supply stop-cock tap is located in the storage room.

The feed pipe to the building is of a conventional polypropylene type. Plumbing – pipes are made of polypropylene pipes for cold and hot water according to the project, mounted water-measuring devices for cold water

The installation appears in satisfactory order.

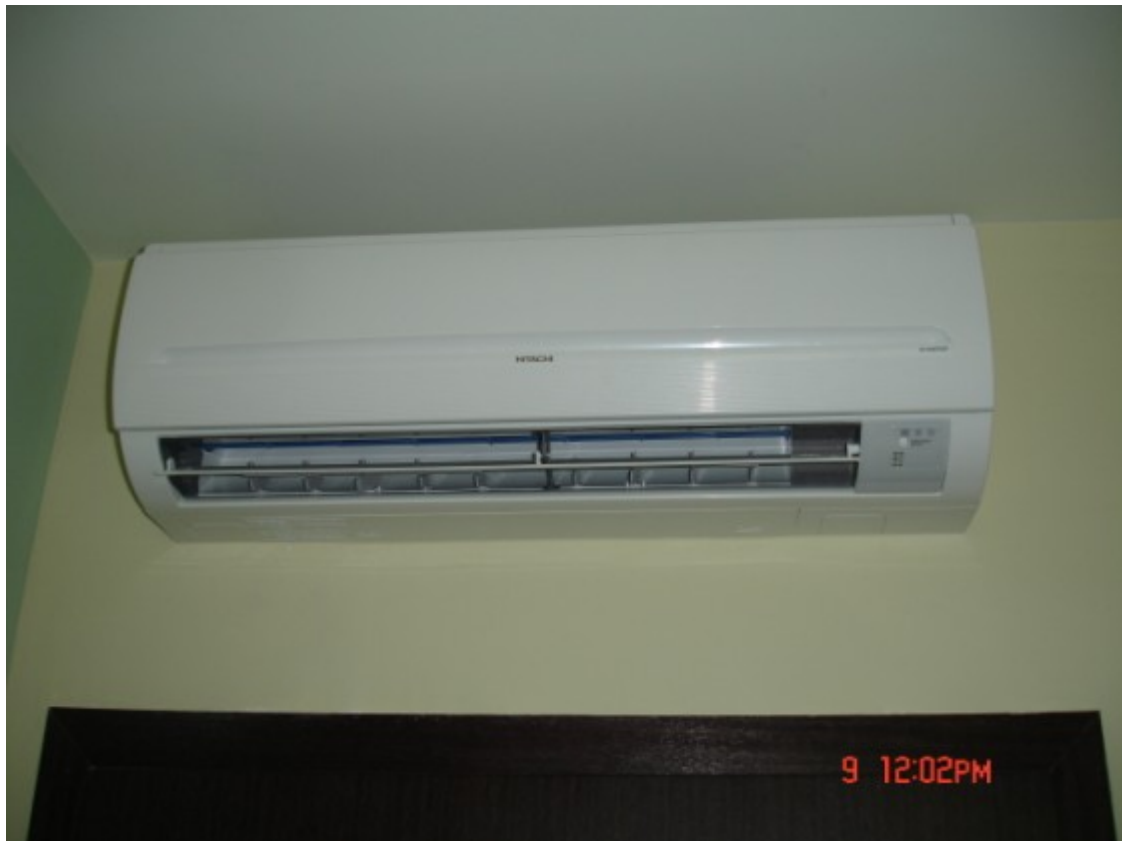
There is a mounted inventor air-conditioning, thermal pump multi-split system according to a project: one exterior and several interior units. The exterior unit was placed on top of the building. The interior units were placed above the door in each of the bedrooms and the living room.
